Report of the Webster County Agricultural Planning Committee  
for 1941

Subject: The Drainage Systems of Webster County

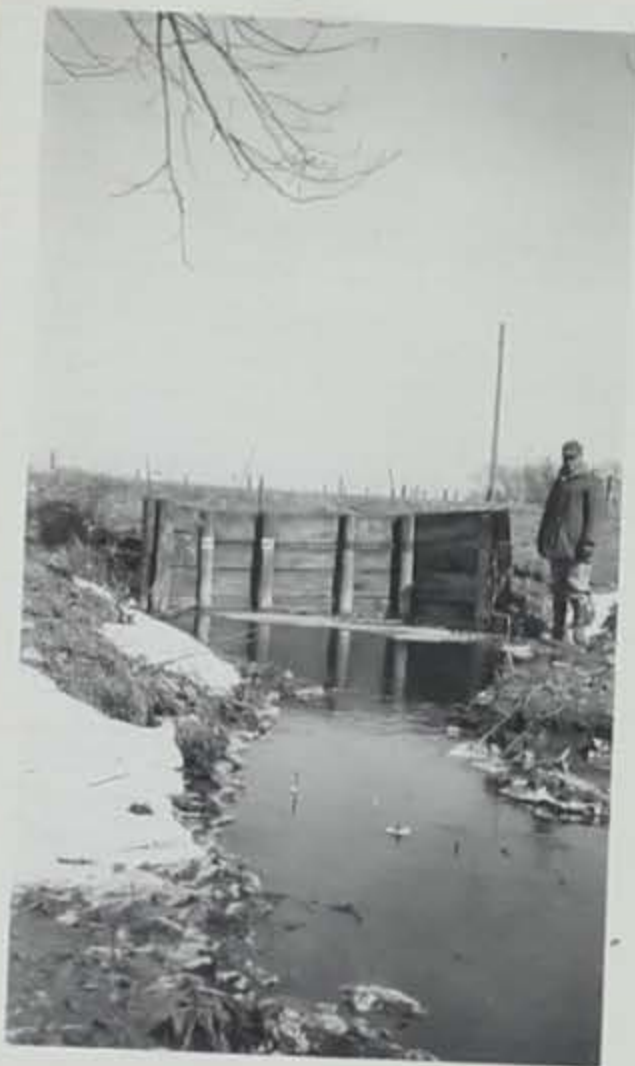
Picture #2

View looking north from a point approximately 50 ft. down stream from end of open ditch Lat. #3 showing Mr. Ray Beismier standing on shoal in front of submerged tile outlet in headwall. Note channel excavated by hand in an effort to obtain an outlet for the tile. Location NW $\frac{1}{4}$  Sec. 22

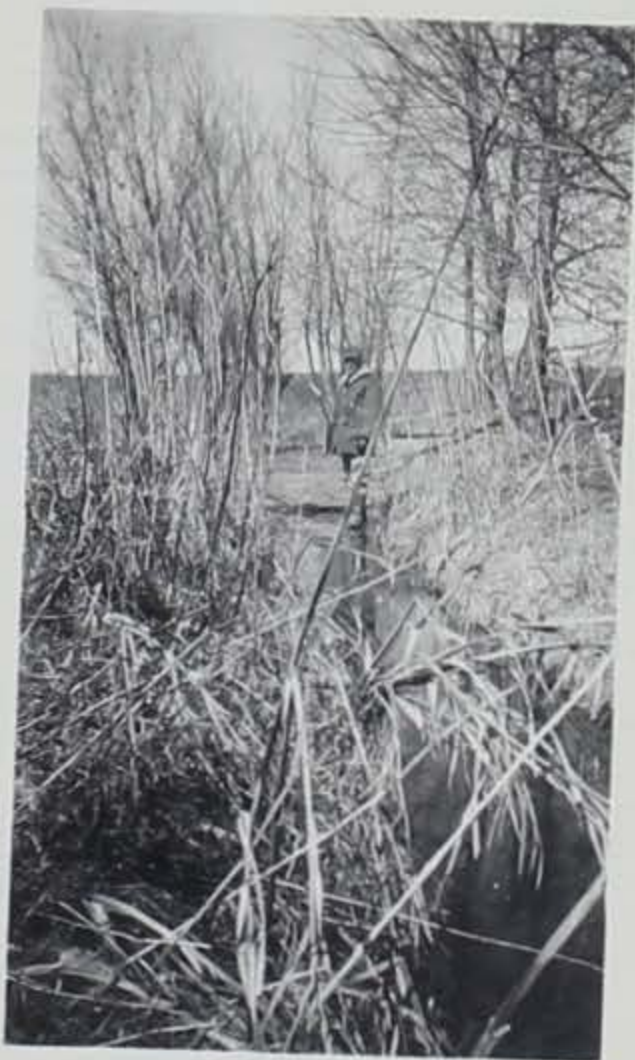
Picture #3

View looking northwest from a point on the east side of wash which extends approximately 150 ft. back into field caused by failure of the tile outlet and surface inlet pipe. Note private tile in back of wash. Location SW $\frac{1}{4}$  Sec. 12.

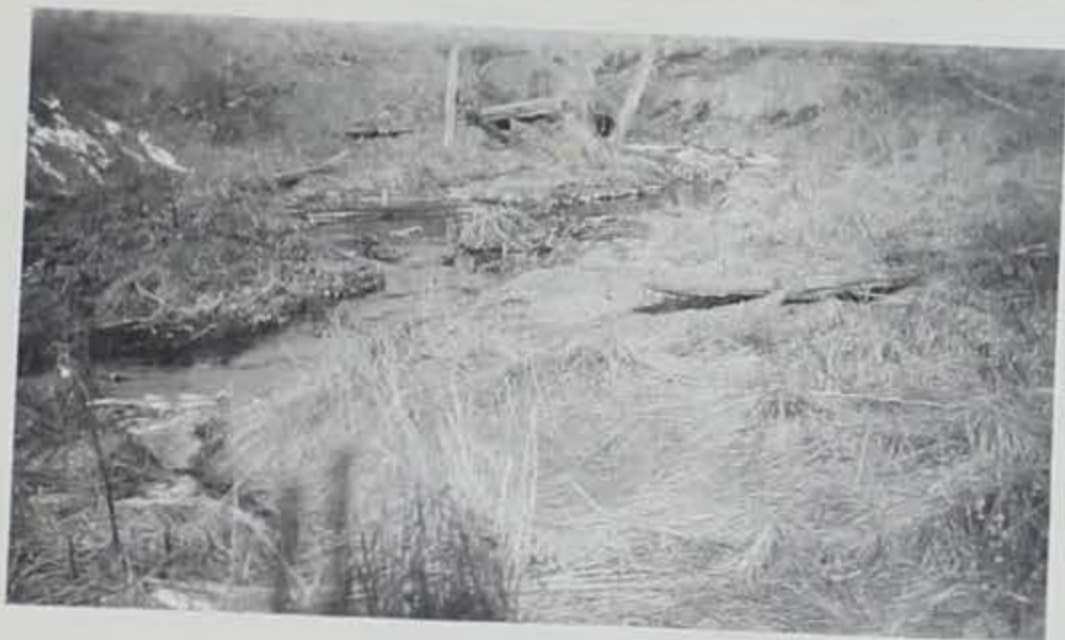
Picture #4

View looking north from south side of ditch showing wash through spoilbank caused by tile failure of picture #3. A large shoal has washed into the ditch and the outlet pipe are covered in the bottom of the wash. Location SW $\frac{1}{4}$  Sec. 12

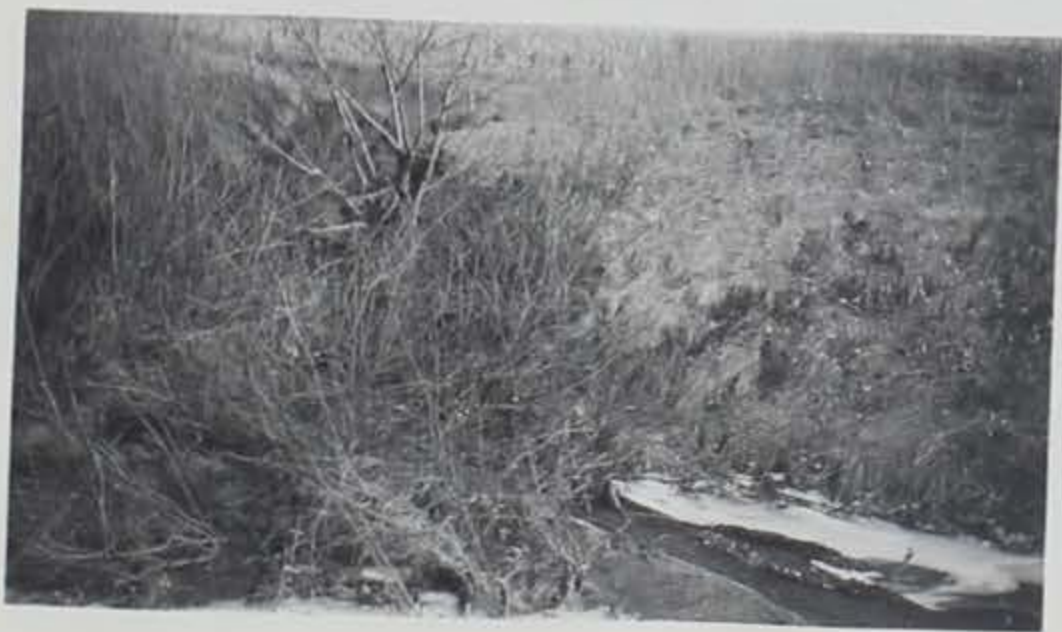
Picture #5

View looking north from south side of open ditch showing a wash that extends approximately 150 ft. back into field where private tile now outlet. Note trash thrown in gully in an attempt to stop erosion. Also note galvanized iron pipe that was once outlet for tile.  
Location SE $\frac{1}{4}$  Sec. 15  
March 18, 1941

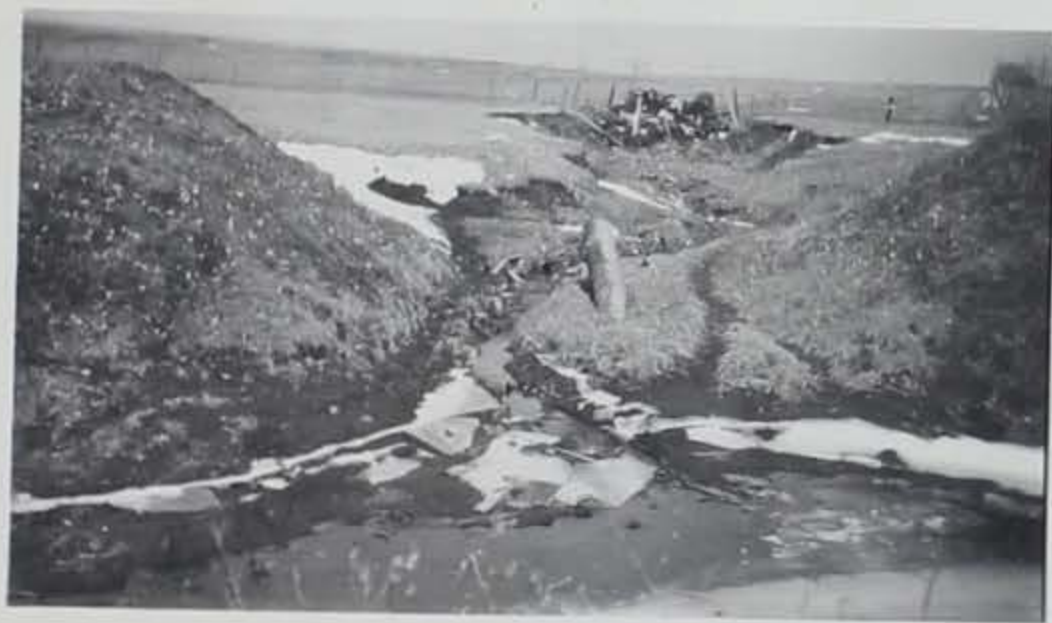
Picture #6

View towards open ditch from a point approximately 150 ft. back in field showing wash around the north side of concrete structure and wash strewn with tile that extends 100 ft. into field.  
Location SE $\frac{1}{4}$  Sec. 15  
March 18, 1941
