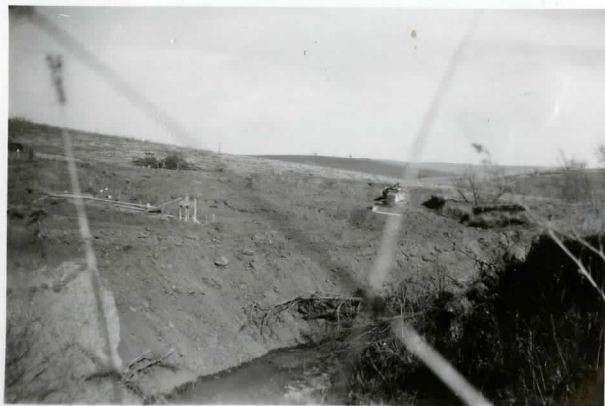
(No. 9)

Bulldozer bringing in earth from left downstream bank. Top of riser forms are seen in left center.

View taken from approximately same spot as picture No. 1.

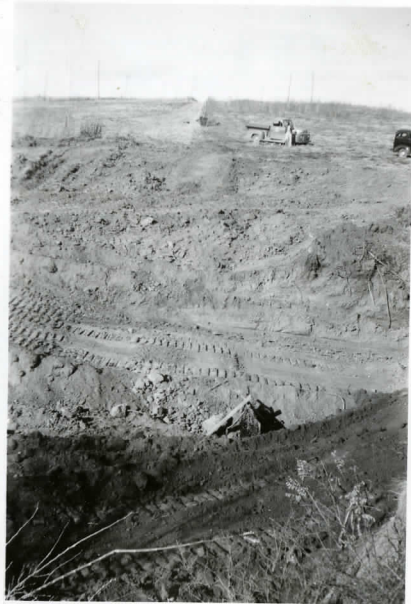
(No. 10)

Looking North. One anti-seep collar yet to be covered. Note lateral to N.W. has been covered.

Fill was supposed to have been placed in equal layers horizontally over the entire fill, keeping the top surface level.
