LEE JOHNSON

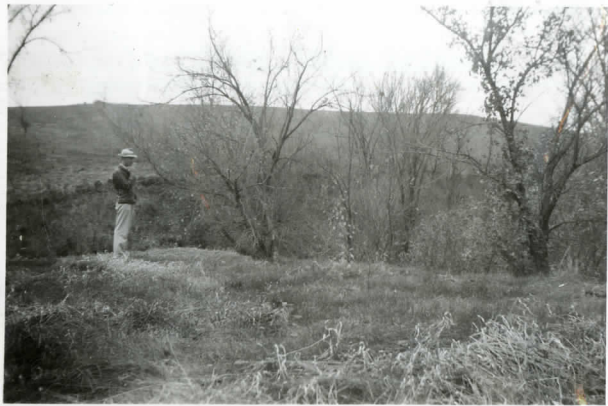
(No. 3)

Looking South-southwest. Observer is facing upstream. North-south property line fence is visible on hill to left. The trees in foreground are growing down in the lateral. This lateral enters from the right.

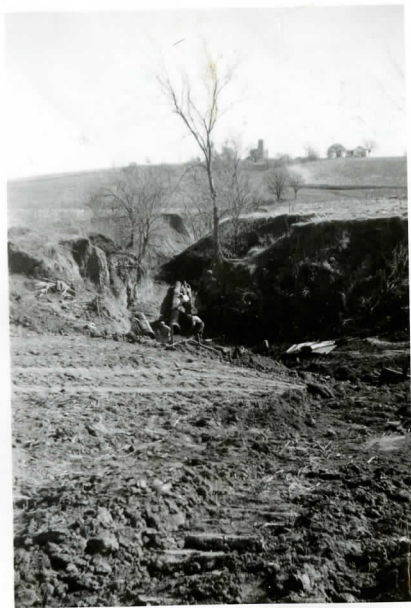
(No. 4)

Picture shows installation of pipe and anti-seep collars. 150 feet of 21" corrugated metal pipe were installed. This pipe was asbestos bonded and asphalt coated.
