SUBJECT: Land Treatment NO. Io-536-1  
LOCATION: 3 miles northwest of Moulton, Iowa.

SCD OR WSHD: Appanoose, MOULTON WATERSHED  
~~PROJECT~~ OWNER: M. Anderson Farm

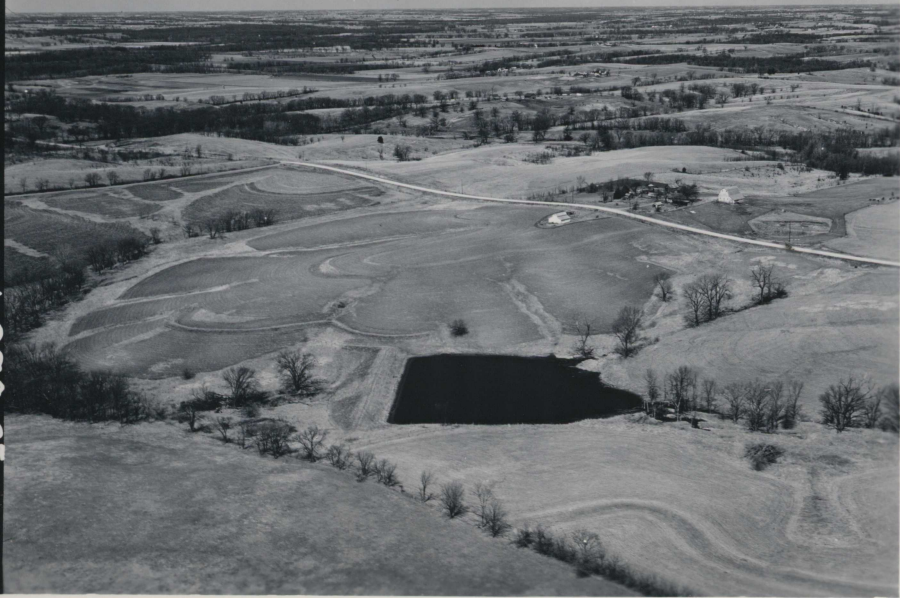
10-536-1

THIS PICTURE SHOWS: Looking northwest at 80 acres of land treatment which contributes to B-5 structure to the south. Treatments are grade stabilizing structure with diversion protection at the northwest end, terracing and contouring of cropland, grassed waterway construction, and land clearing.

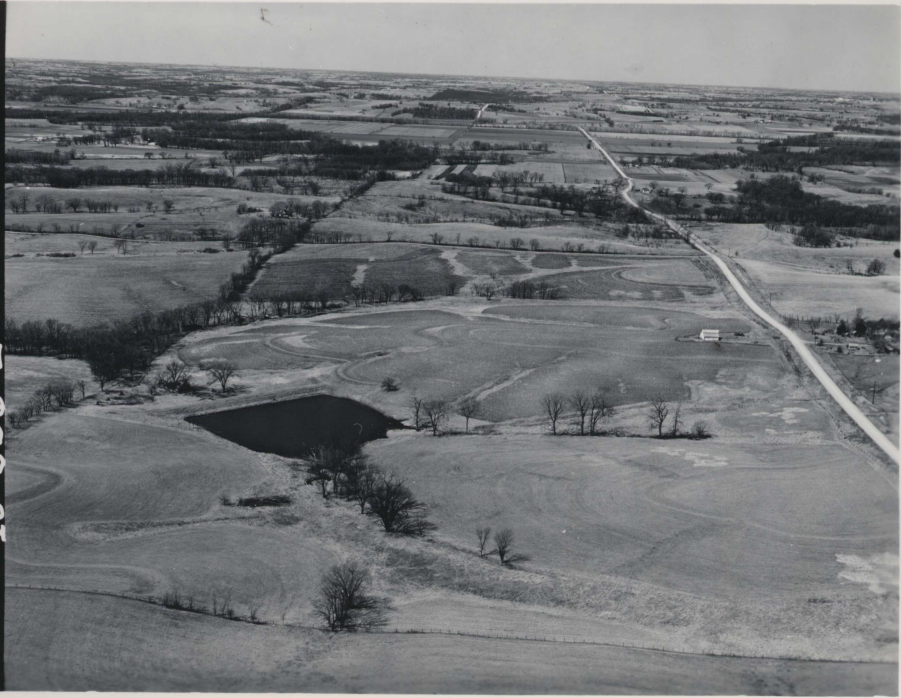
SUBJECT: Land Treatment NO. 10-536-2  
LOCATION: 3 miles northwest of Moulton, Iowa.

THIS PICTURE SHOWS: Looking west at 80 acres of land treatment north of structure B-5. Treatment shown is not cost shared with P.L. 566 funds. Shown are terraced cropland with contouring, grassed waterways, grade stabilizing structure and contributing diversion, and land clearing.

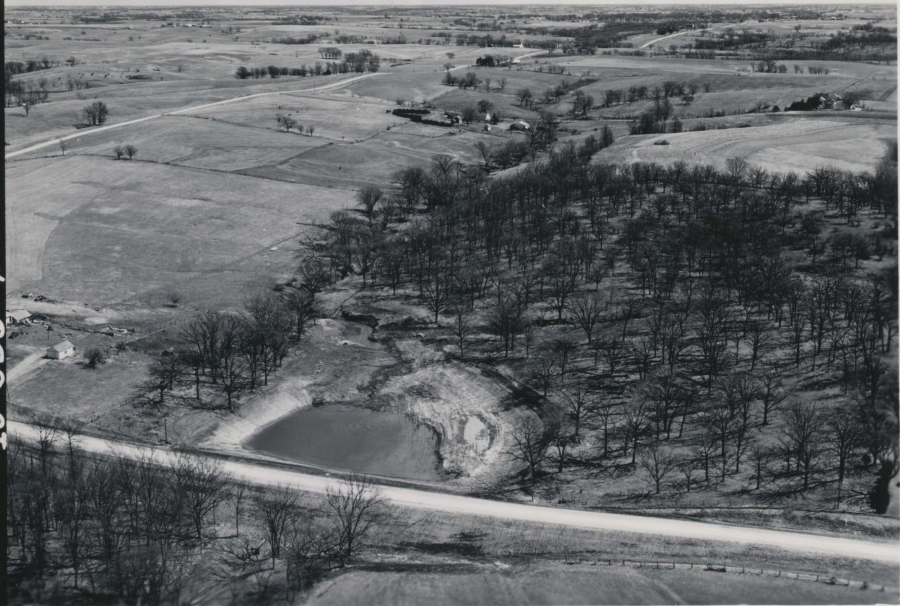
SUBJECT: Structure B-9 NO. 10-536-4  
LOCATION: 3 miles west and south of Moulton, Iowa.

THIS PICTURE SHOWS: B-9 structure is located on farm-to-market road and contracted by Appanoose County Board of Supervisors under P.L. 566. The timbered area belongs to J. Frank Daniels and to the left center is J. R. Lindley farm. Land treatment includes strip cropping and or terracing, contouring, waterway construction, ponds, and pasture seedings of birdsfoot trefoil.

*After picture of B-9; "Before" picture is 10-490-2*

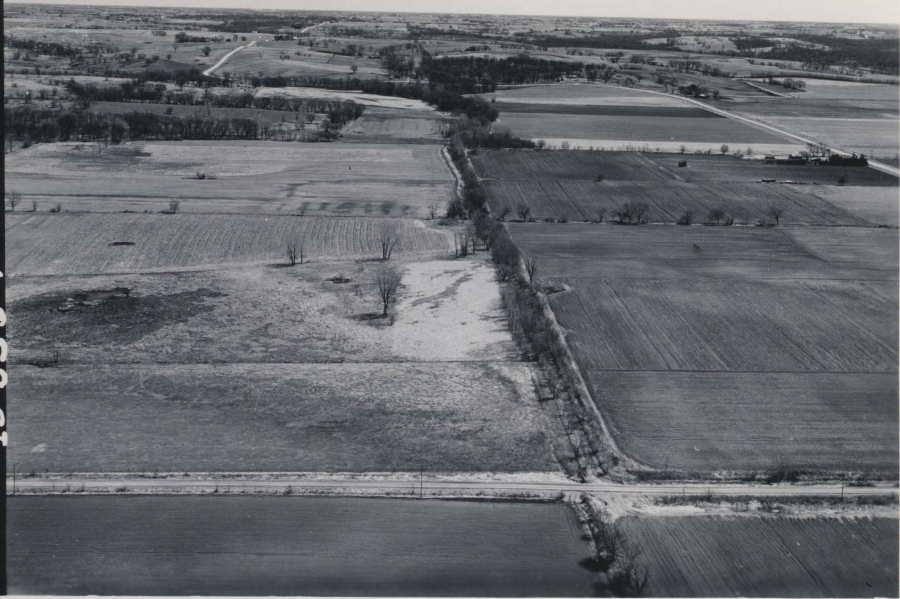
SUBJECT: B-100 - Before NO. 10-536-7  
LOCATION: 4 miles west of Moulton, Iowa.

B-100 channel construction location on the upper E-W  
section, looking east. The channel will extend 1/2  
mile from the farm road in the foreground, straight  
east, and end at a concrete weir-notch grade stabili-  
zation structure. The channel will turn south at  
the lower right-hand corner and follow the old ditch  
to the Chariton River.

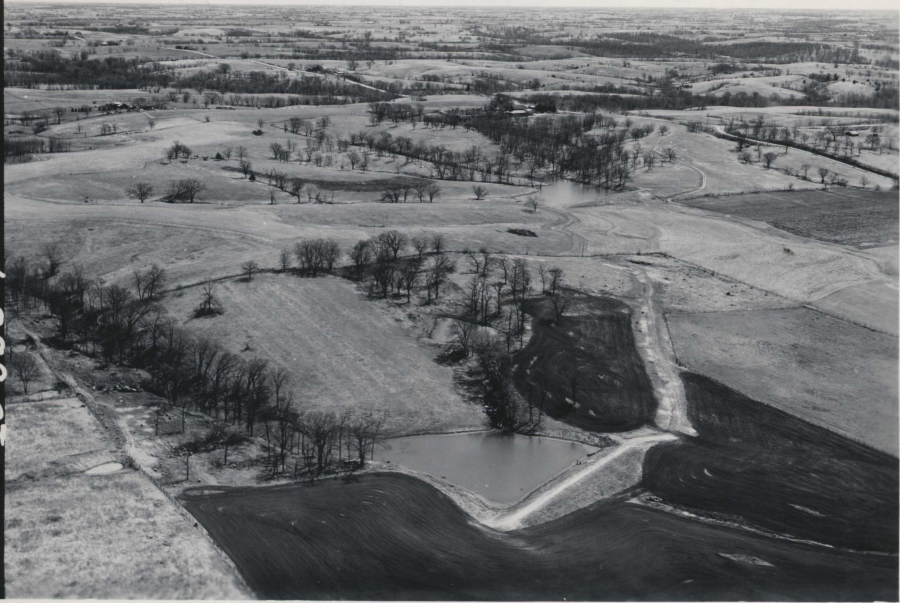
10-536-9

Runoff Retarding; Land Treatment  
SUBJECT: Structure NO. Io-53649  
LOCATION: 3½ miles southwest of Moulton, Iowa.

THIS PICTURE SHOWS: Retarding structure with contributing diversion bringing additional acreage. Other land treatments include waterway construction below the dam, farm pond in center, and pasture improvement. The fence line along the left border has earth fills with drainage - no water gaps. Grade stabilization structure will be built in the ditch at the left center on the fence line. See Io-536-12 and Io-537-1. This is the Stuart Daniels farm and Art Jay farm in the background.

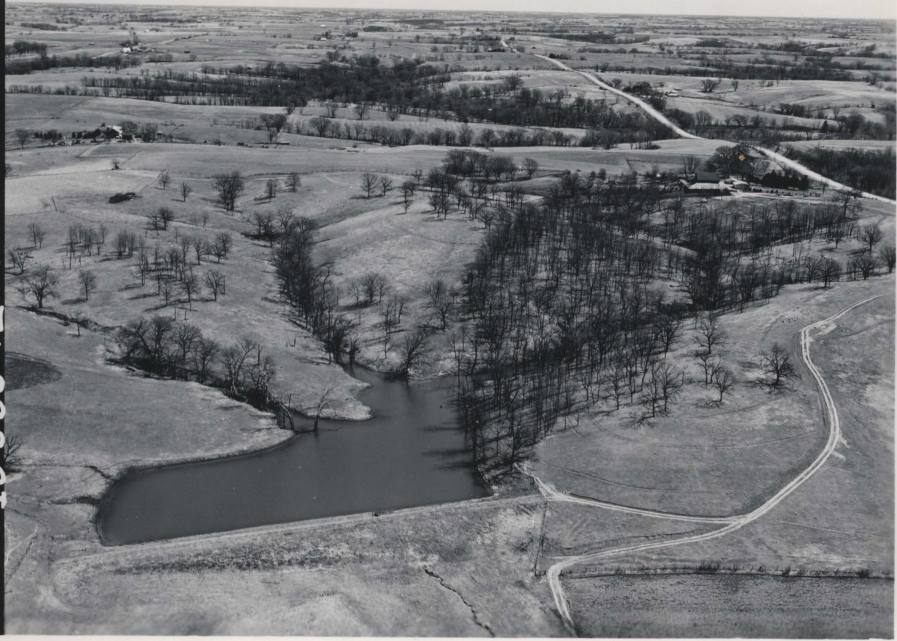
10-536-12

SUBJECT: Structure NO. Io-536-12  
LOCATION: 3½ miles southwest of Moulton, Iowa.

THIS PICTURE SHOWS: Land treatment runoff reduction or  
retarding structure and constructed waterway below.  
At left center a contributing diversion brings in  
additional acreage behind the dam. Terraced ridge tops  
are at the head of the subwatershed. Field strip  
cropping is at the lower right outside of the photo.  
Terracing and contouring are in the lower right. See  
photos Io-536-9 and Io-537-1.
