DATE May 1965 NO. 50-L-96-2  
SUBJECT : Tile Outlet Damage  
PHOTOGRAPHER : Cal Cox  
LOCATION : 1 mile west and 3 miles south of  
Gilmore City, Iowa.  
SOIL OR WATERWAYS : Pocahontas SCD-81  
FIGURE :

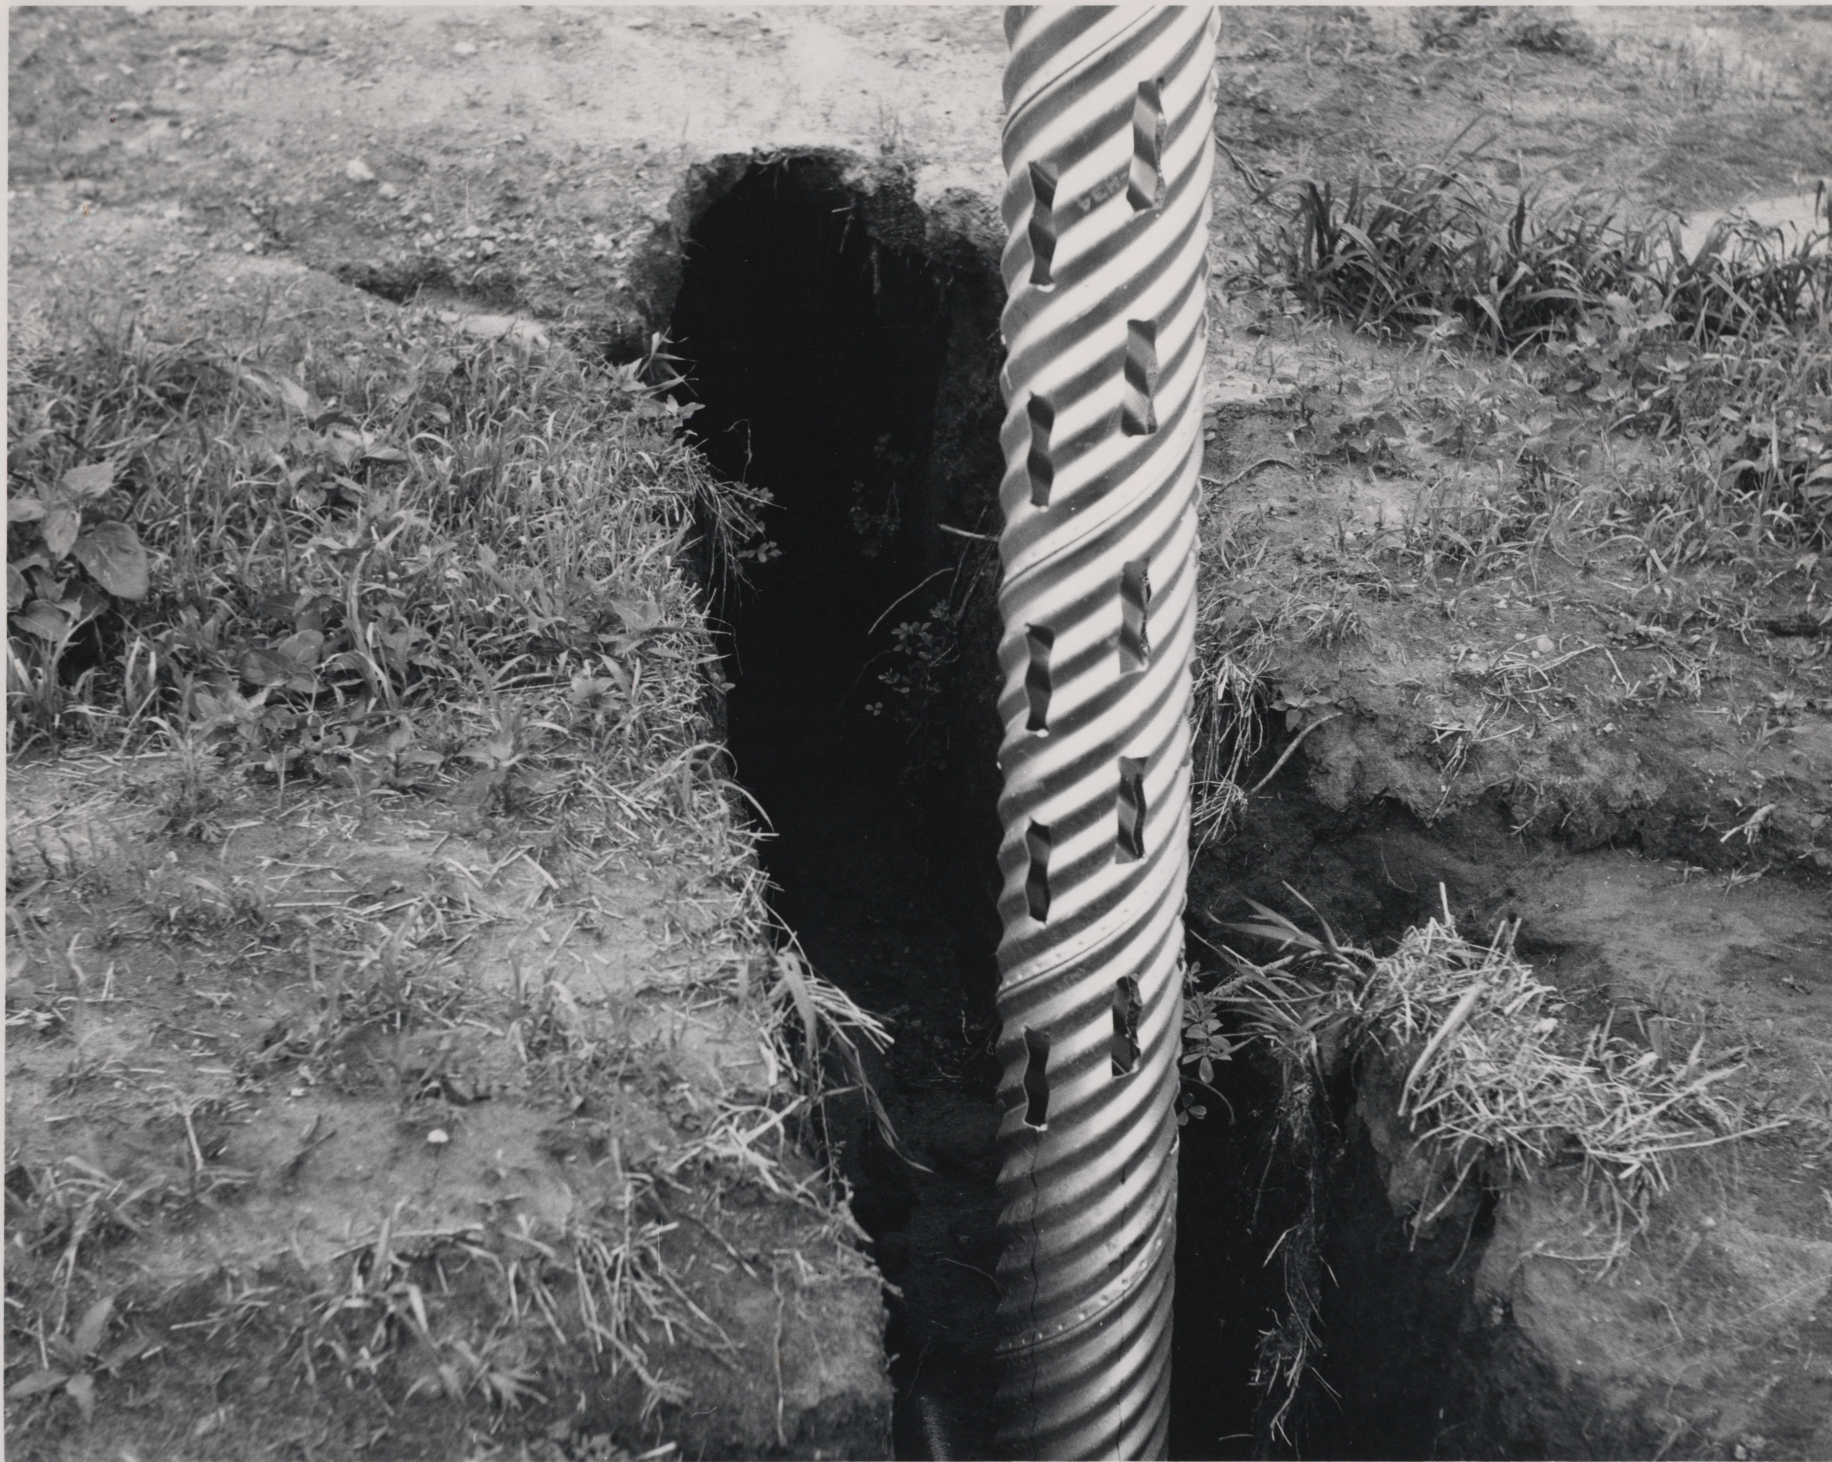
THE PICTURE SHOWS Tile line break through on bench-  
type terraces on the Leahy farm. The damage was  
caused by heavy spring thaw.
