DATE: 11/5/70

RC & D Project Proposal

Indian Hills Com. College-Centerville  
Campus

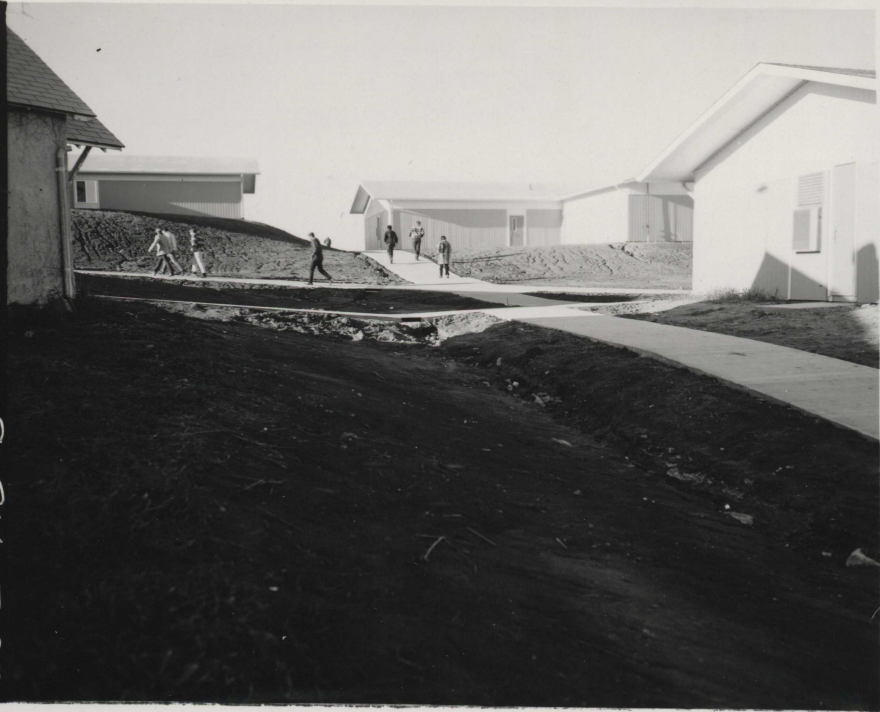
NO. IO-L-415-5

THIS PICTURE SHOWS: one of twelve views within the building complex of the Centerville campus showing uncontrolled erosion and sedimentation. RC & D project proposal includes soil treatments, underground drains for surface and building runoff, sodding steepest slopes and seeding remaining areas. Erosion control and netting will be used where most practical. This photo shows general view from the N.E. of interior sidewalk, unprotected slopes and building elevation. Farm tenements in left foreground. See view #6 for close-up.

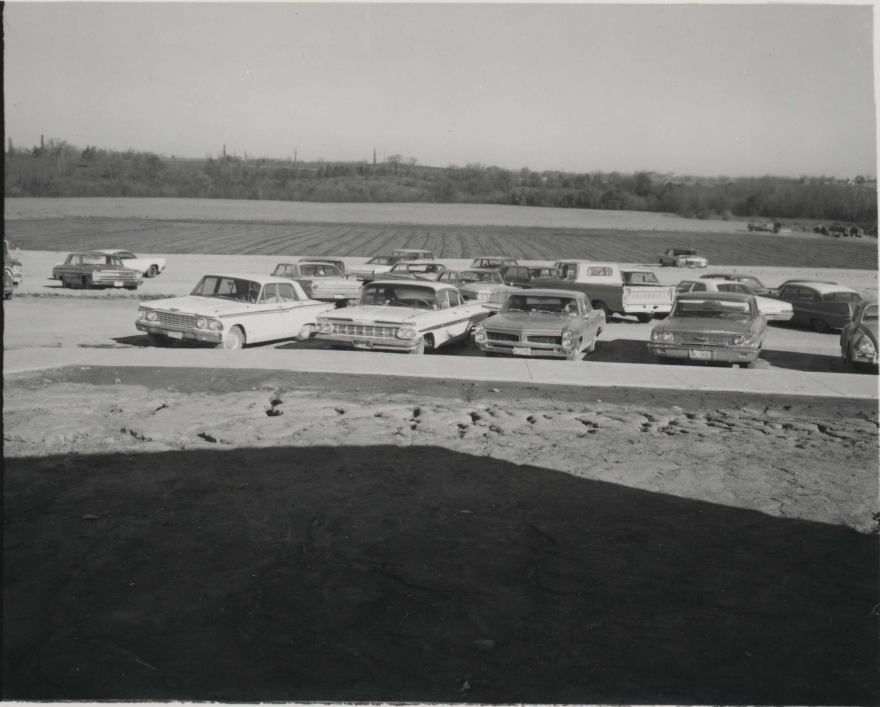
NO. IO-L-415-16

THIS PICTURE SHOWS: one of twelve views within the building complex of the Centerville campus showing uncontrolled erosion and sedimentation. RC&D project proposal includes soil treatments, underground drains for surface and building runoff, sodding steepest slopes and seeding remaining areas. Mulch and netting will be used where practical. This photo shows campus parking area north of building complex. Cropland in background will be converted to recreation area.

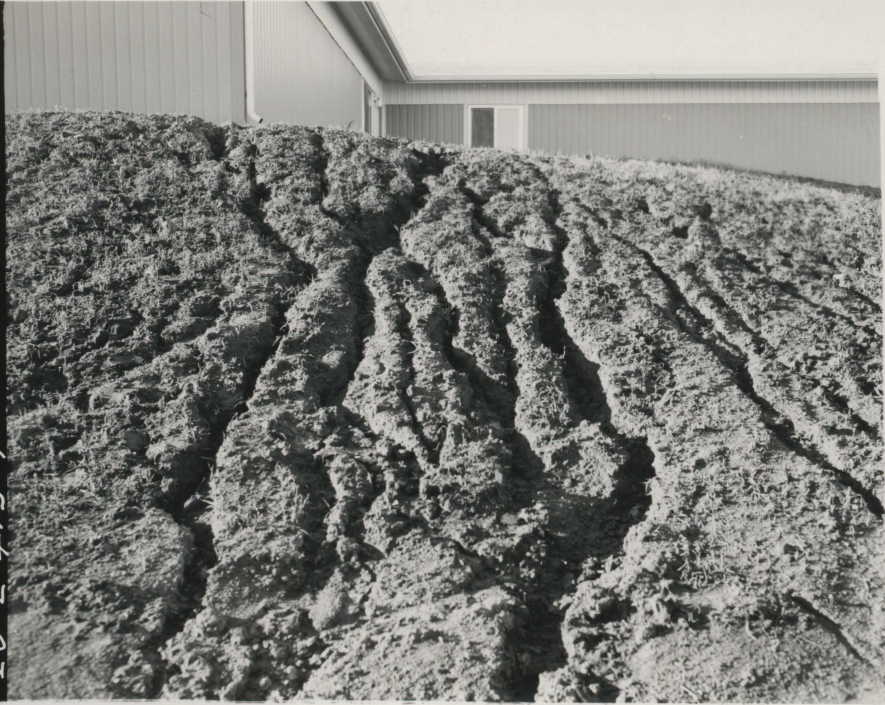
20-L-415-7

THIS PICTURE SHOWS: one of twelve views within the building complex of the Centerville campus showing uncontrolled erosion and sedimentation. RC & D project proposal includes treatments, underground drains for surface and building runoff, sodding steepest slopes and seeding remaining areas. Mulch and netting will be used where most practical. This picture shows result of concentration of runoff on one-to-one slope. Foundation of this building endangered if not controlled soon. See view #9 for general view of this area.

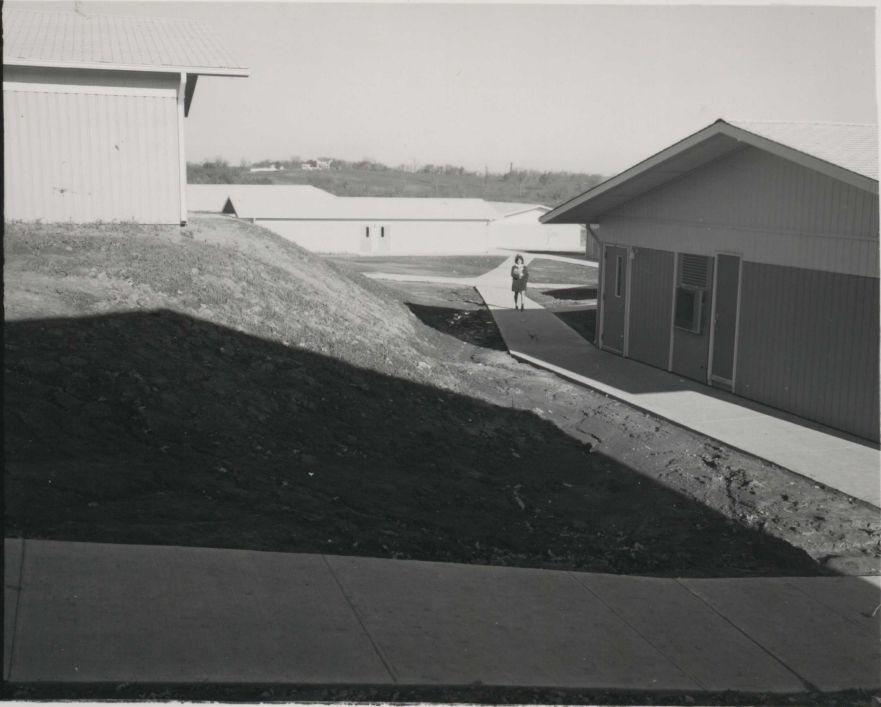
NO. IO-L-415-9

THIS PICTURE SHOWS one of twelve views within the building complex of Centerville campus showing uncontrolled erosion and sedimentation. RC & D project proposal includes soil treatments, underground drains for surface and building runoff, grading steepest slopes and seeding remaining areas. Mulch netting will be used where most practical. This photo shows general view from S.E. of same slope (left) shown in photo #8. Note difference in building elevations. Building on left is cross shaped and its roof drainage is divided equally to eight downspouts. See photo #10 for view from other building elevation.

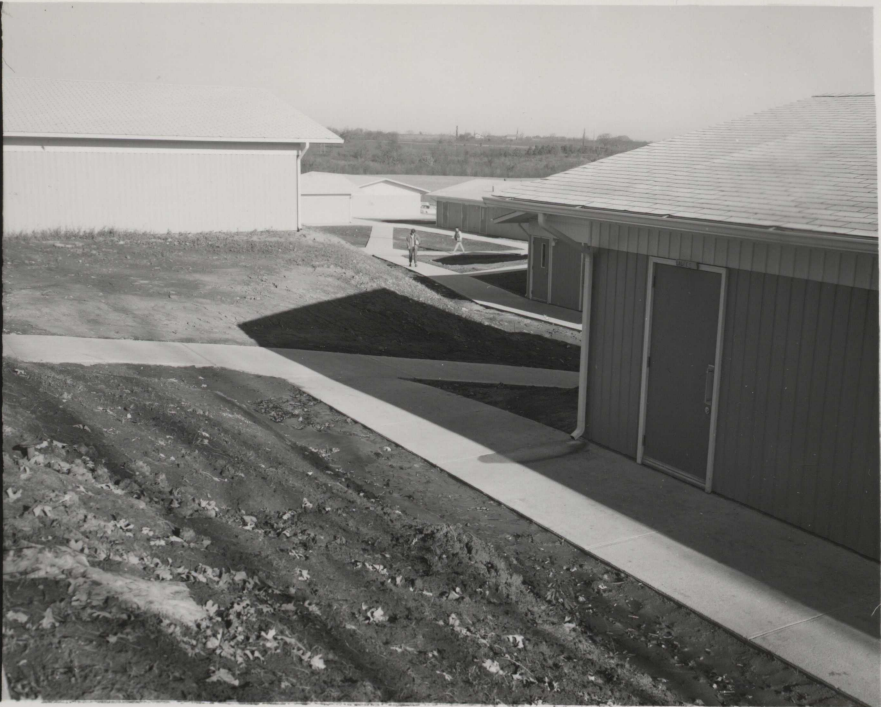
NO. 10-L-415-10

THIS PICTURE SHOWS: one of twelve views within the building complex of the Centerville Campus showing uncontrolled erosion and sedimentation. RC & D project proposal includes soil treatments, underground drains for surface and building runoff, sodding steepest slopes and seeding remaining areas. Mulch and seeding will be used where most practical. This photo shows general view from S.E. through campus building complex. Each building is located on different elevation. Poor draining onto sidewalks can produce ice in wintertime creating safety hazard.

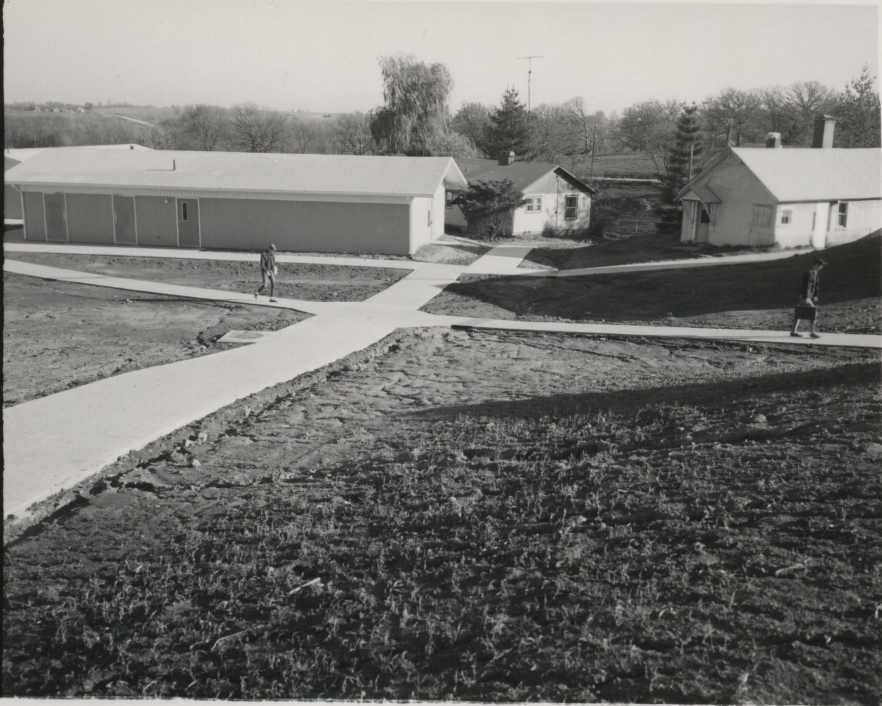
NO. Io-I-415-11

THIS PICTURE SHOWS: one of twelve views within the building complex of the Centerville campus showing uncontrolled erosion and sedimentation. RC&D project proposal includes soil treatments, underground drains for surface and building runoff, sodding steepest slopes and seeding remaining areas. Mulch and netting will be used where most practical. This picture shows general view down hill from center of building complex toward camera station in photo #5. Considerable runoff water is concentrated here and then it flows between the two buildings in right background.

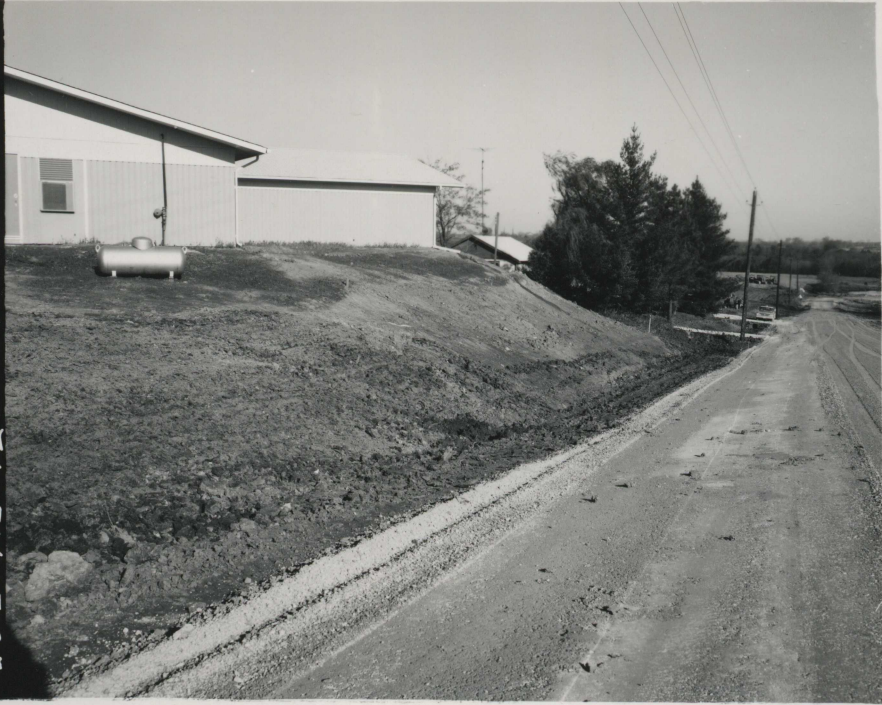
NO. IO-L-415-12

THIS PICTURE SHOWS: one of twelve views within the building complex of the Centerville campus showing uncontrolled erosion and sedimentation. RC&D project proposal includes soil treatments, underground drains for surface and building runoff, sodding steepest slopes and seeding remaining areas. Mulch and netting will be used where most practical. This photo shows east edge of campus building complex bordering First Street. Two alternatives to sodding this slope are: 1. Soil treatment and establish emerald crown vetch with help from mulch and netting or, 2. Construct retaining wall.

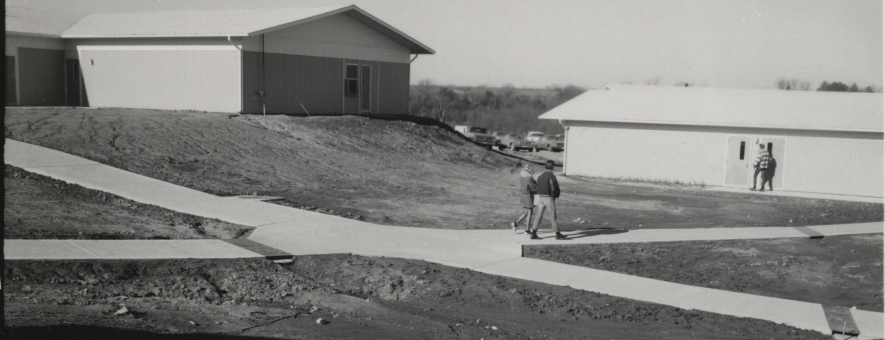
NO. IO-I-415-15

THIS PICTURE SHOWS: one of twelve views within the building complex of the Centerville campus showing uncontrolled erosion and sedimentation. RC&D project proposal includes soil treatments, underground drains for surface and building runoff, sodding steepest slopes and seeding remaining areas. Mulch and netting will be used where most practical. This photo shows erosion and silt fans in central area of building shown in photo #14. Soil eroding from the slope between the two buildings is filling drainage way at lower level

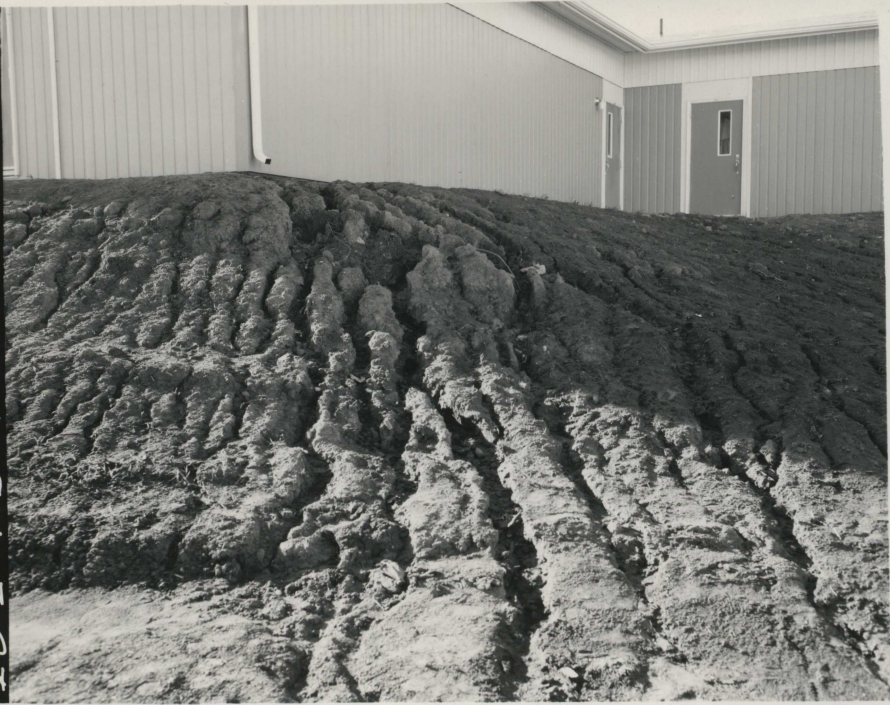
NO. IO-L-415-14

THIS PICTURE SHOWS: one of twelve views within the building complex of the Centerville campus showing uncontrolled erosion and sedimentation. RC&D project proposal includes soil treatments, underground drains for surface and building runoff, sodding steepest slopes and seeding remaining areas. Mulch and netting will be used where most practical. This photo shows still another critical erosion area adjacent to same building shown in photo #13. This slope is shown between two buildings in photo #15.

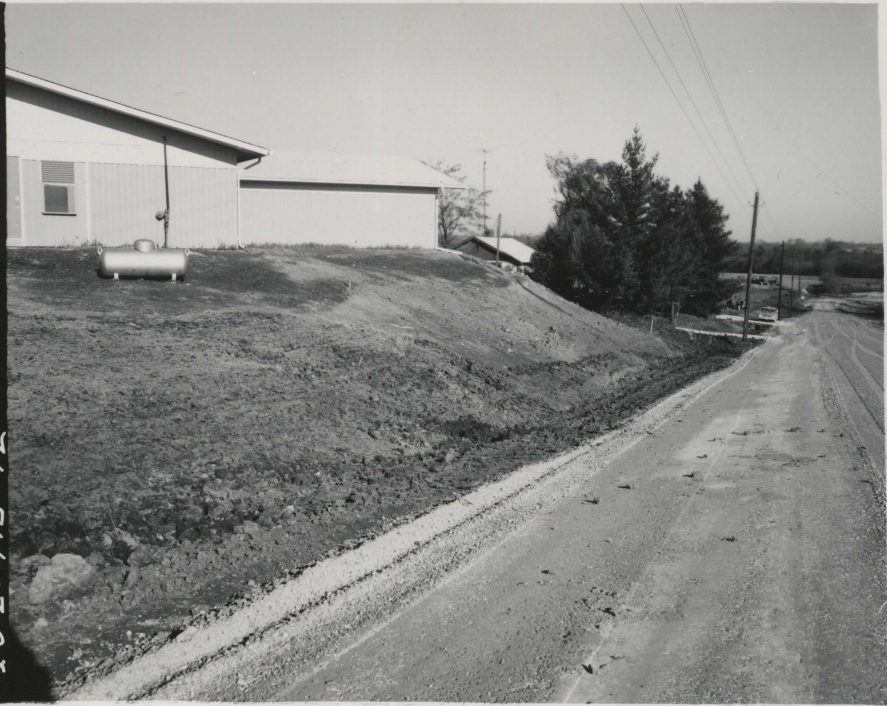
NO. IO-L-415-12

THIS PICTURE SHOWS: one of twelve views within the building complex of the Centerville campus showing uncontrolled erosion and sedimentation. RC&D project proposal includes soil treatments, underground drains for surface and building runoff, sodding steepest slopes and seeding remaining areas. Mulch and netting will be used where most practical. This photo shows east edge of campus building complex bordering First Street. Two alternatives to sodding this slope are: 1. Soil treatment and establish emerald crown vetch with help from mulch and netting or, 2. Construct retaining wall.
