Report of the Webster County Agricultural Planning Committee  
for 1941

Subject: The Drainage Systems of Webster County

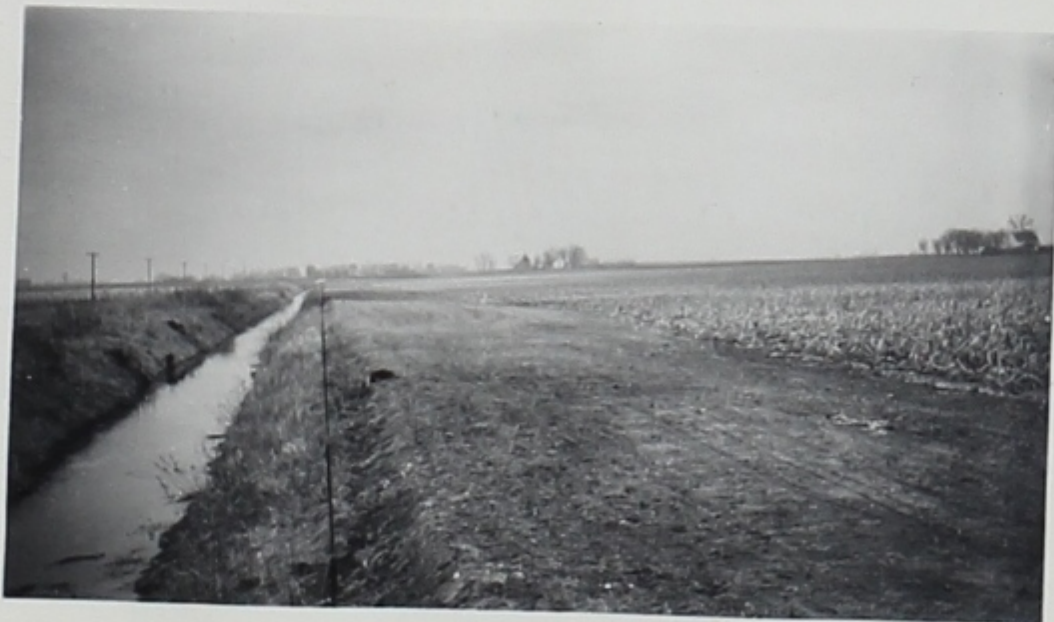
Location: west side of Sec. 18  
April 10, 1941

View looking upstream from east side of open ditch showing a section of ditch on which the spoilbank has been recently leveled by a local contractor. Note how high point of leveled bank is near the ditch so that rain falling on bank drains away from the ditch and enters the ditch through surface inlet pipe.
