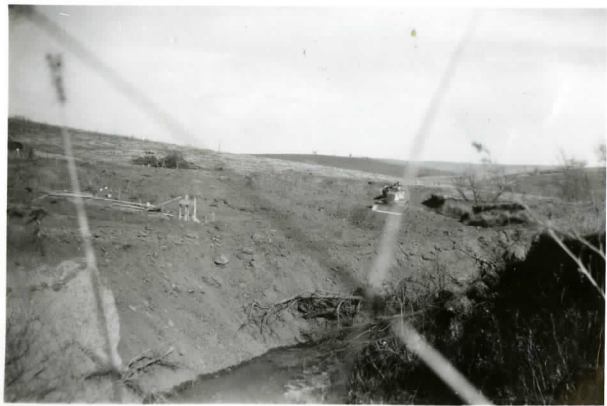
(No. 10)

Bulldozer bringing in earth from left downstream bank. Top of riser forms are seen in left center.

View taken from approximately same spot as picture No. 1.

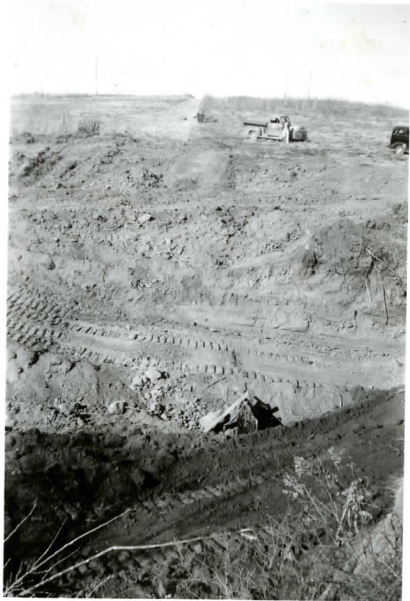
Looking North. One anti-seep collar yet to be covered. Note lateral to N.W. has been covered.

Fill was supposed to have been placed in equal layers horizontally over the entire fill, keeping the top surface level.
