# Pine Lake Wildlife Club's Conservation Project Completed Near Here

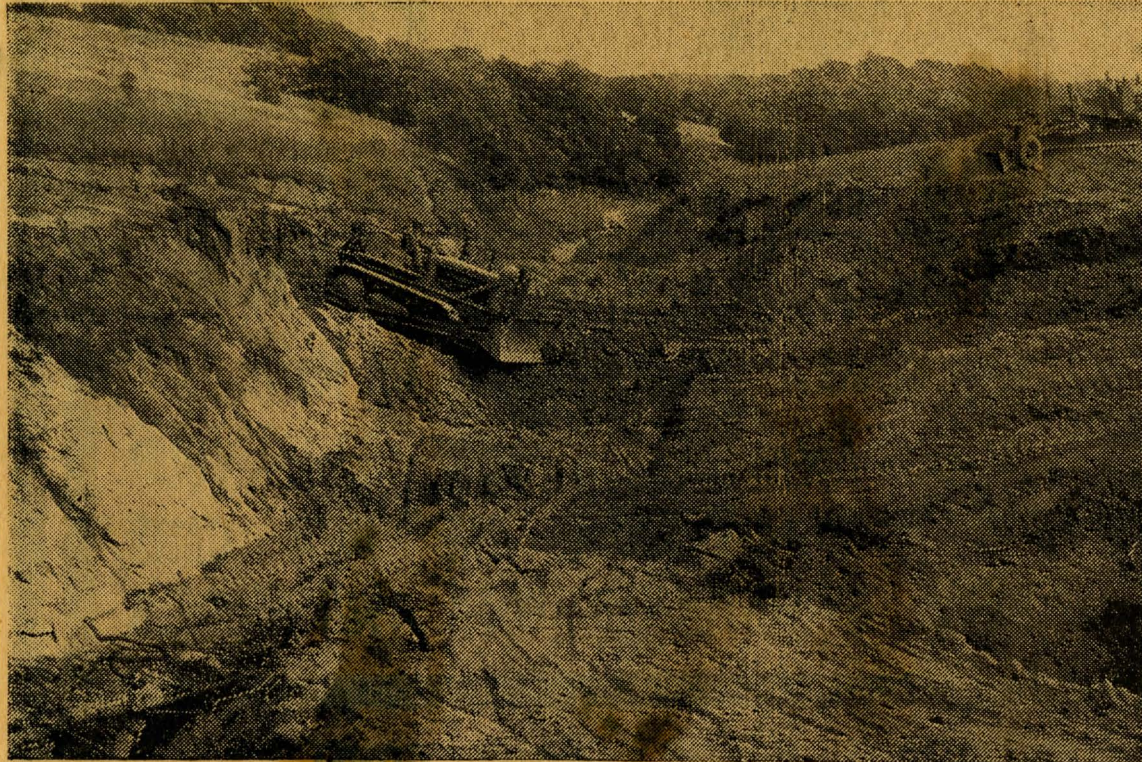
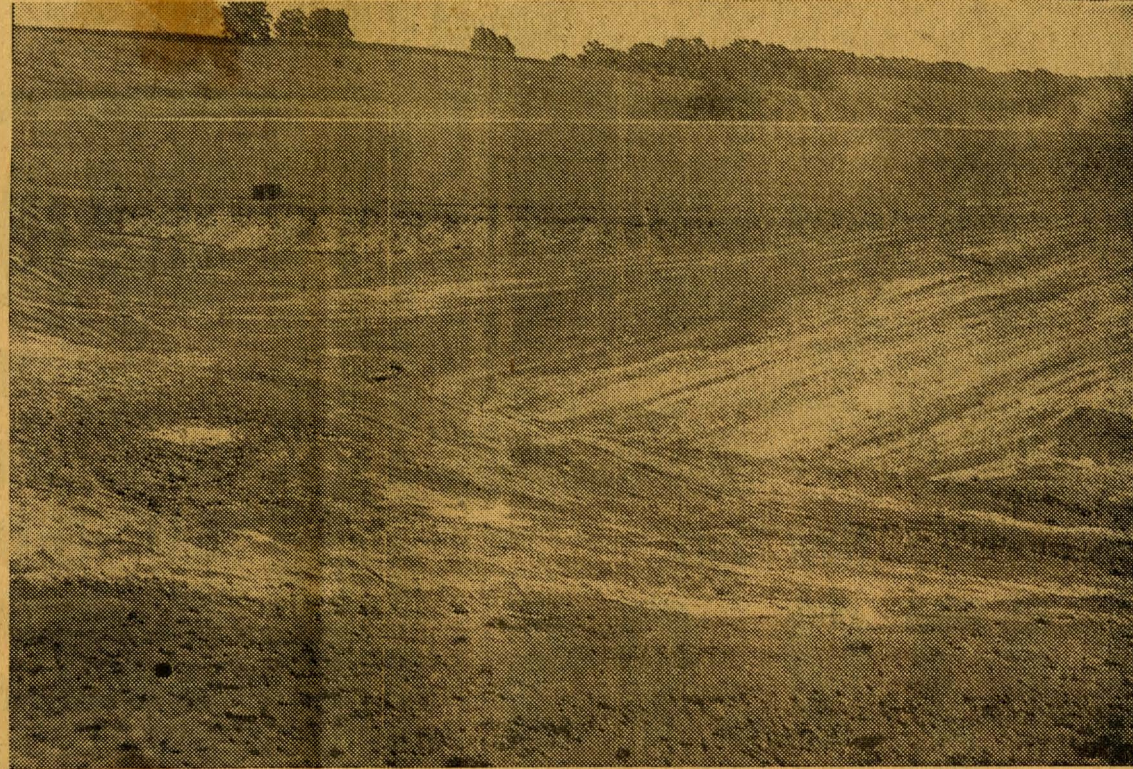
The above before and after pictures pretty well illustrate work done the past three weeks on construction of a dam across a large ravine that enters the middle portion of Upper Pine Lake from the west. In the left photo can be seen the deep ravine that

has for years been causing an erosion problem at the lake. The right photo was taken following completion of the dam which consists of some 5,535 cubic yards of earth fill. The dam is 26 feet high from the bottom of the gully which is close to 40 feet wide. Back-

ground trees which are very visible in the left picture can barely been seen in the right shot. The project, which cost some \$3,000, was planned, financed and will now be maintained by the Pine Lake Wildlife Club, which has contributed a great deal toward con-

servation practices and the improvement of Pine Lake for years. The Wildlife Club investigated erection of the dam for a couple of years before construction work began the early part of August. It was built for the purpose of erosion and silt confinement.
