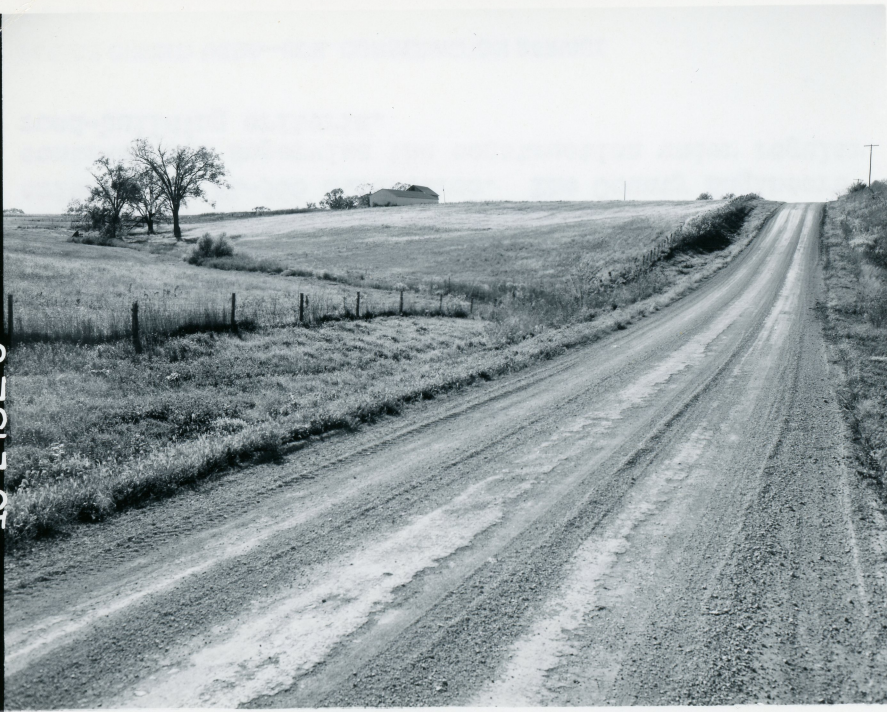
10-L-152-5

DATE: 10/7/66 NO. 10-L-152-3  
SUBJECT : Conservation - Road Structure, Before  
PHOTOGRAPHER : Stark  
LOCATION : 1½ mile west of Iconium, Iowa.

THIS PICTURE SHOWS: A before photo of conservation - road structure that will control a gully and store silt to protect a small area draining into Rathbun Dam. This is one of three such structures planned by Appanoose County Engineers, SCD, and SCS in a short section of county road adjacent to the Rathbun Lake. SCS surveys and designs are employed using same criteria as PL-566 structures. The County Engineers contract and supervise the construction under regular road-building criteria.

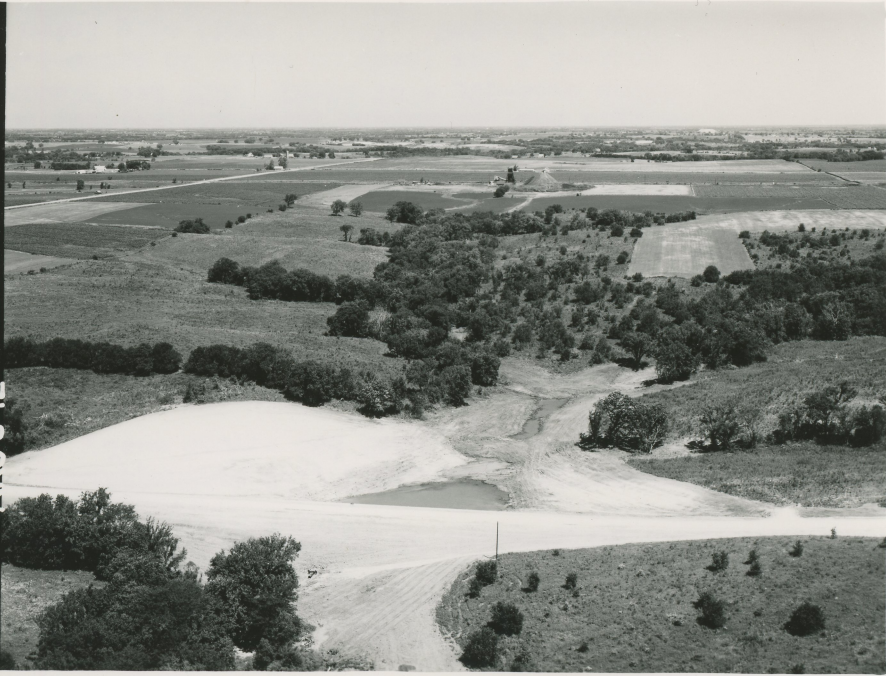
DATE 7/11/65 NO. NRC-8-12  
SUBJECT : Conservation - Road Structure  
PHOTOGRAPHER : Erwin W. Cole  
LOCATION : 4 miles southwest of Centerville,  
Iowa.  
SCD OR WATERSHED : Appanoose Co., SHOAL CREEK WATERSHED  
RIDGE OWNERS : Jess Hoover and Sons

THIS PICTURE SHOWS: Third conservation road structure built in Appanoose County under provisions of understanding between County Board of Supervisors and District Soil Commissioners. It was designed and constructed under same specifications as P.L. 566 program, but no federal funds are involved in construction. Maintenance also comes under regular county road funds. Farmers sign same easements as P.L. 566 and furnish all land, easements, and rights-of-way to county and SCD. There is a 305-acre drainage area; 4.4-acres of water surface; and a 24-inch corrugated metal pipe (hood inlet). Water is piped under road for livestock.

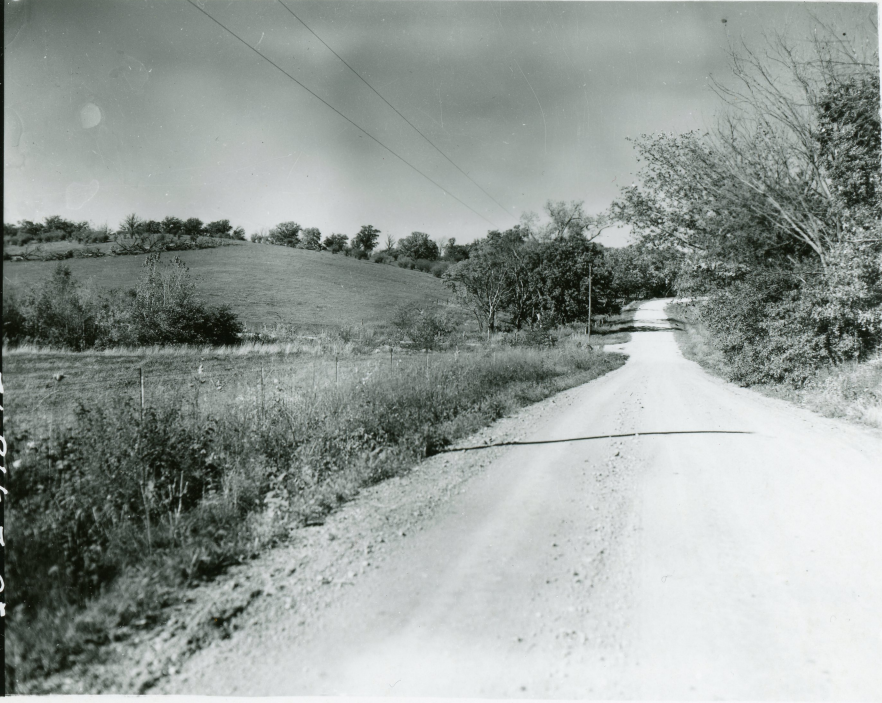
10-4-418-12

SUBJECT Proposed site Conservation-Road Structure

LOCATION : 3 miles S.W. of Moulton, Iowa

THIS PICTURE SHOWS: Proposed site for conservation-road structure serving 3 property owners and County Board of Supervisors. Proposed road would bend to the left at this point and an earthen fill built across the valley in center of photo. Grade stabilization, sediment storage and runoff control would be major conservation benefits. A similar structure is proposed to the left of the road curve in the background of the photo. These structures complement the recently completed P.L.566 watershed structural program in the Moulton Watershed.

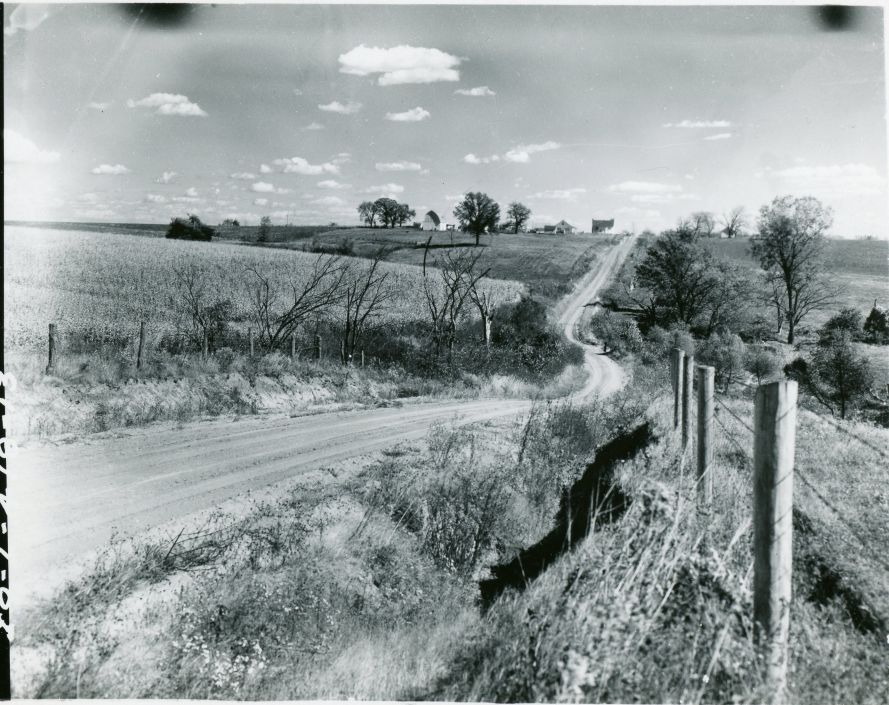
20-1-10-13

: Proposed site Conservation-Road Structure

: N. of Plano, Iowa, 7 miles

THIS PICTURE SHOWS: Proposed site of conservation-road structure serving 2 property owners and Appanoose Co. Board of Supervisors. Bridge will be replaced with earth fill & hood inlet spillway. Grade stabilization will be a major benefit. Structure will also provide storage for sediment which would otherwise pollute Lake Rathbun immediately downstream. Old wooden bridges on county road system are unsafe and expensive to repair. Modernized road system calls for elimination of bridges wherever possible & replaced with conservation road structures.

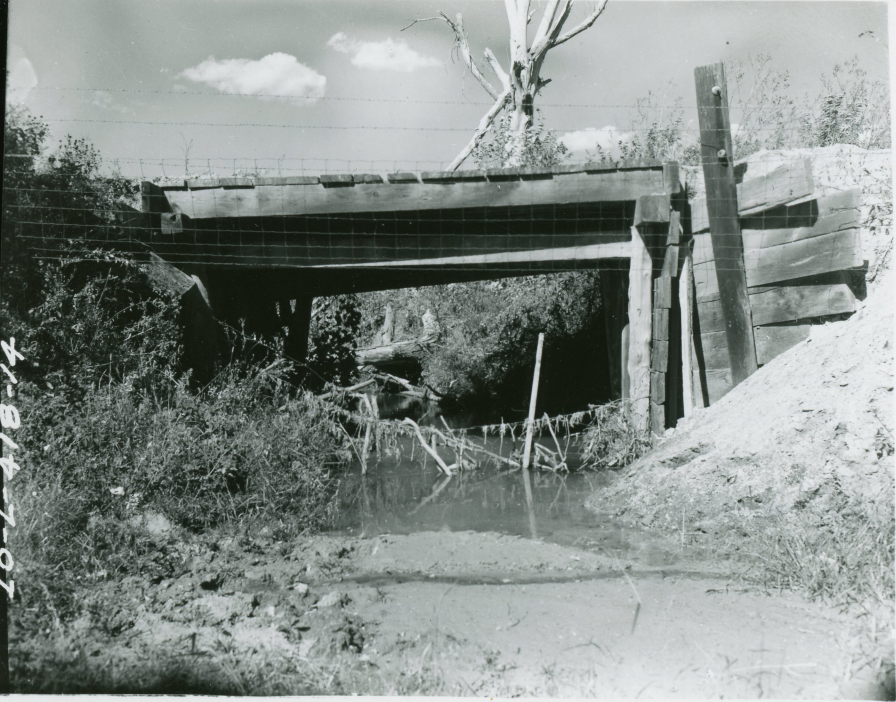
10-1-41B-14

SUBJECT Proposed site Conservation-Road Structure

LOCATION : 7 miles N. of Plano, Ia.

THIS PICTURE SHOWS: Proposed site of conservation-road structure serving 2 property owners and Appanoose Co. Board of Supervisors. Bridge will be replaced with earth fill & hood inlet spillway. Grade stabilization will be a major benefit. Structure will also provide storage for sediment which would otherwise pollute Lake Rathbun immediately downstream. Old wooden bridges on county road system are unsafe and expensive to repair. Modernized road system calls for elimination of bridges wherever possible & replaced with conservation road structures.
