Ill-247 - Dikker's farm, Cedarville, Ill. 8/26/36.

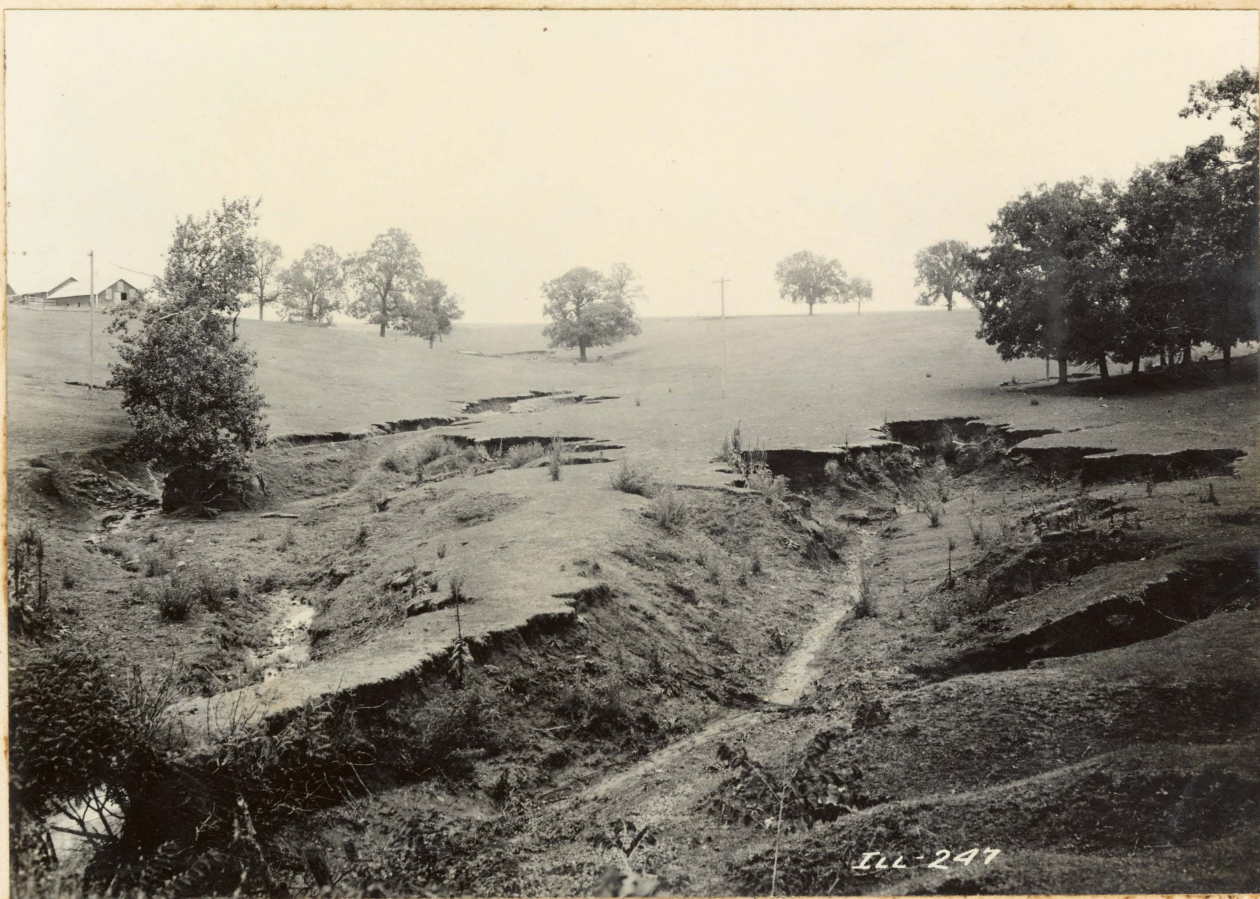
Close grazing has removed the grass cover from this pasture inducing serious erosion. A highway culvert under U. S. 74 was placed low enough under the road to allow an overfall to be created above the culvert. This overfall has worked back branched and is destroying the pasture.
