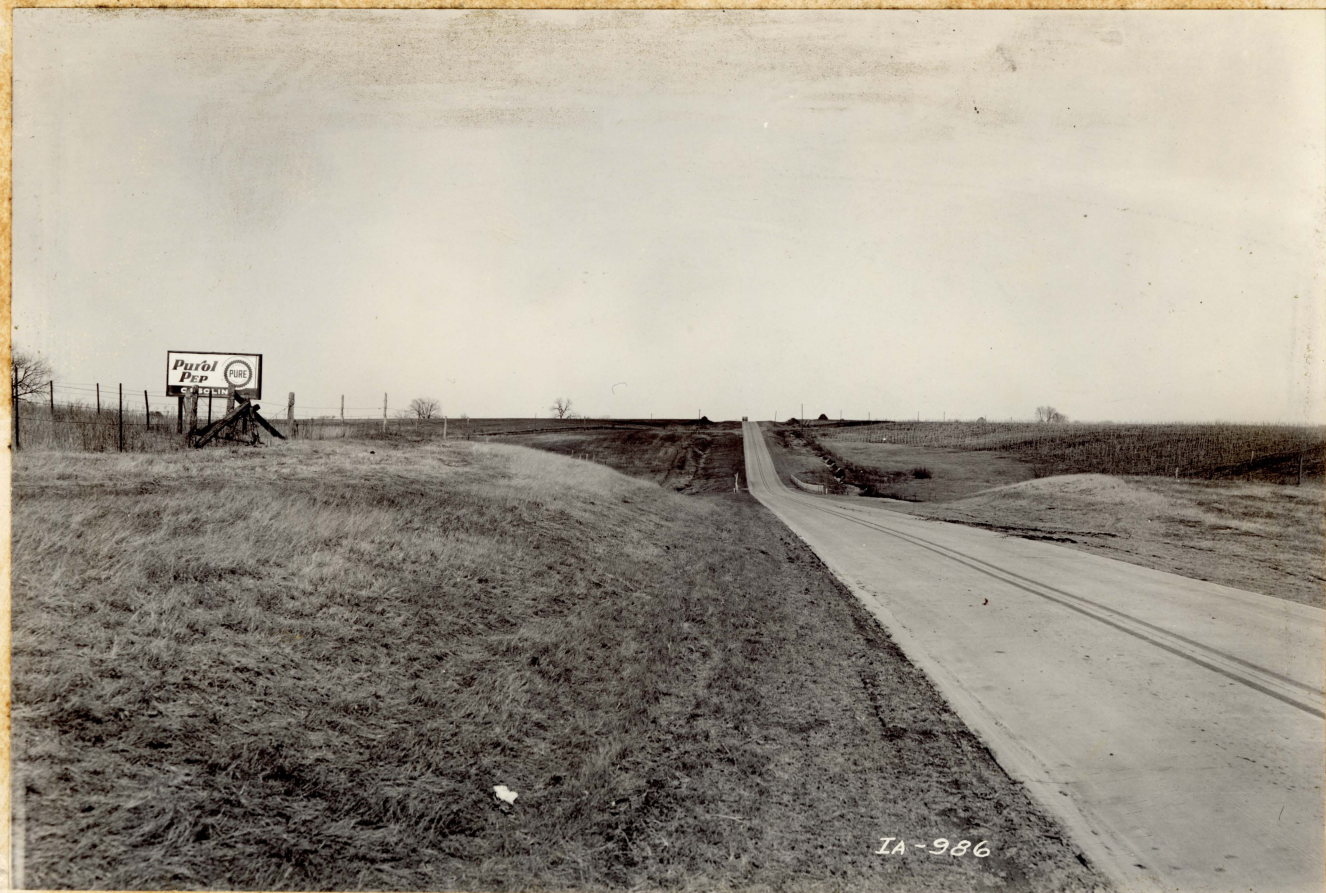
Ia-986 - The highway was constructed in 1929, same time as the picture Ia-985. The back slope was 2 to 1, however. The same seeding and treatment were used in both places. Note the lack of erosion and good growth of vegetation as compared with Ia-985.
