C. W. HANCOCK FARM -- Cass

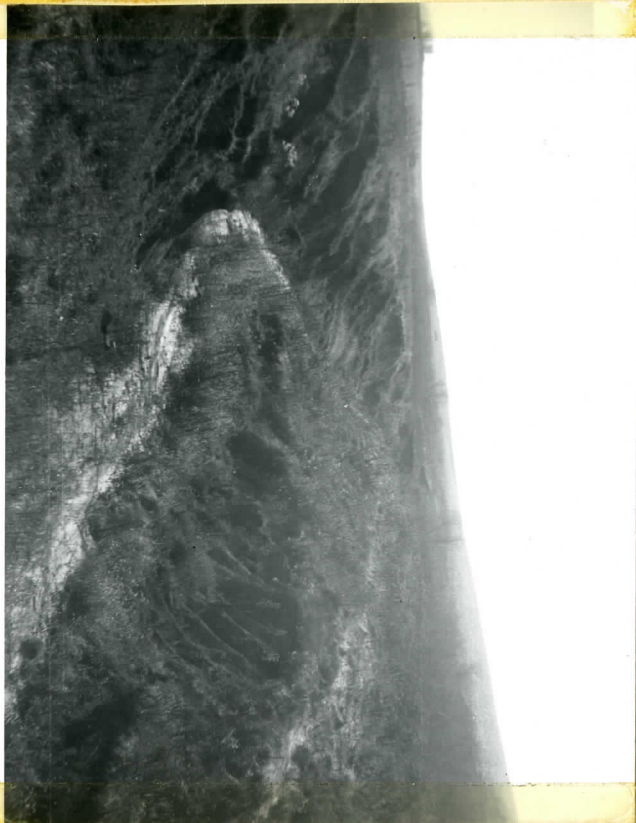
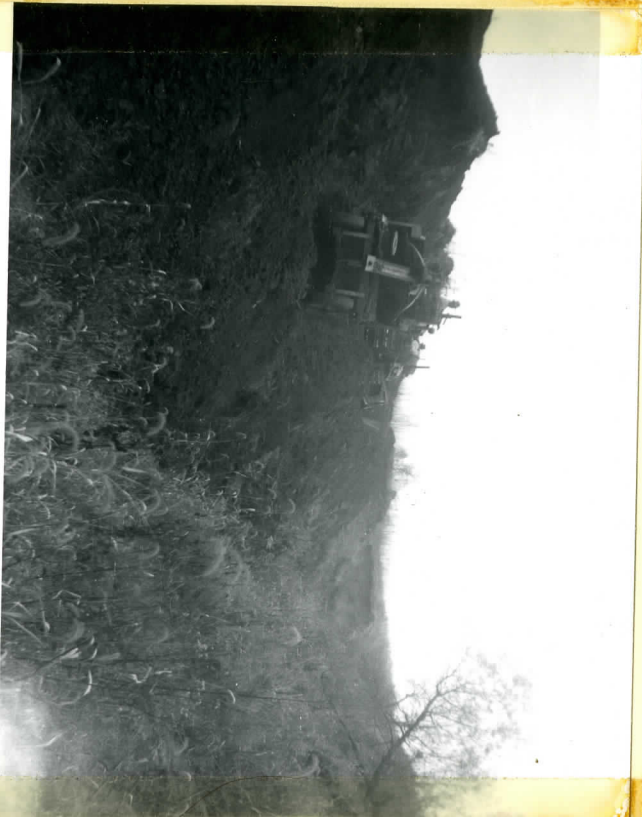
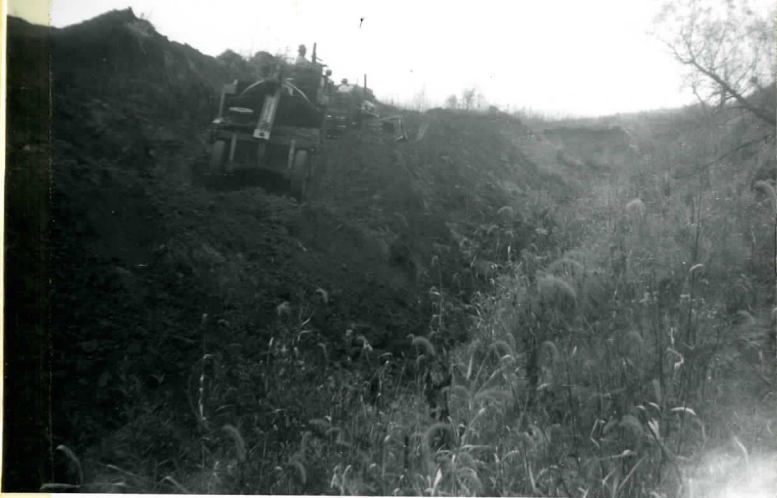
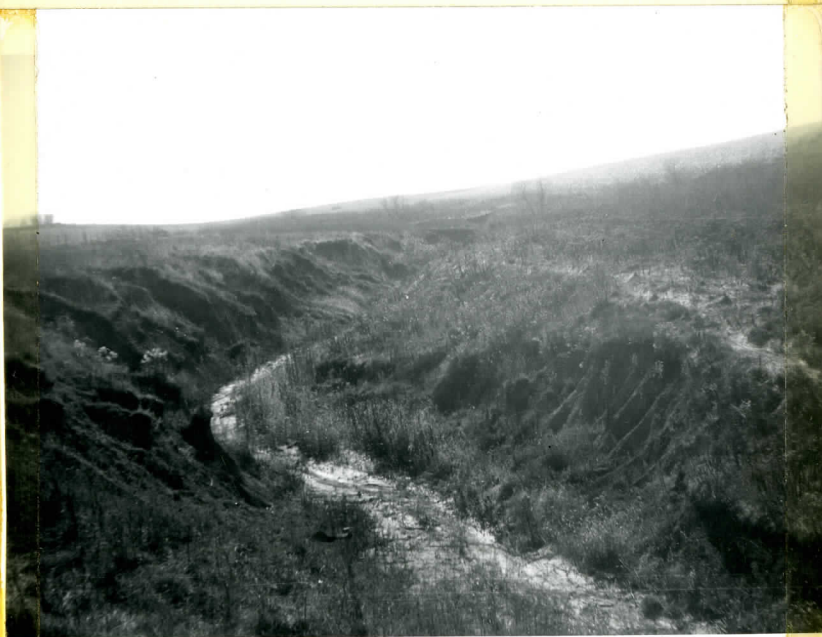
Views of the gully before and during construction. The excavation is for the pipe spillway, which had a total fall in it of 9 feet.
