C. W. HANCOCK FARM -- Cass

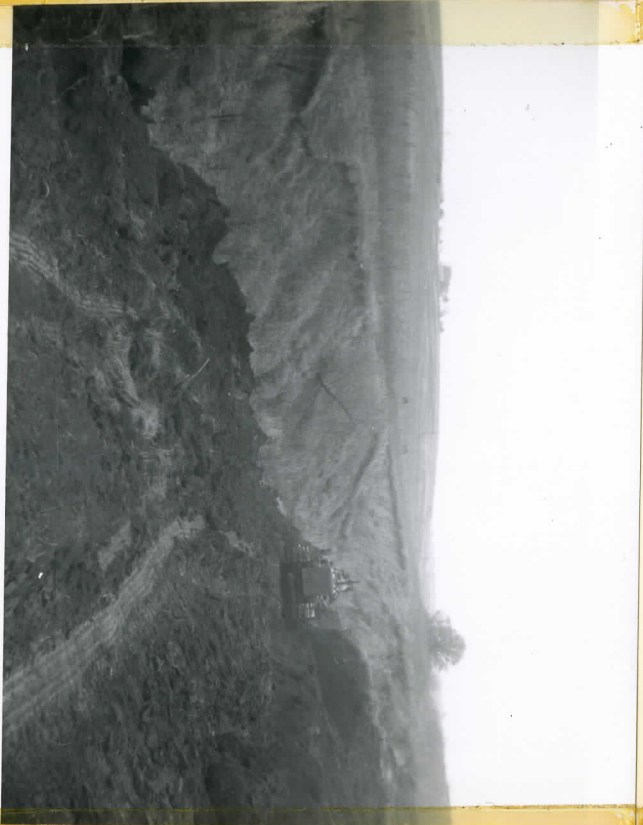
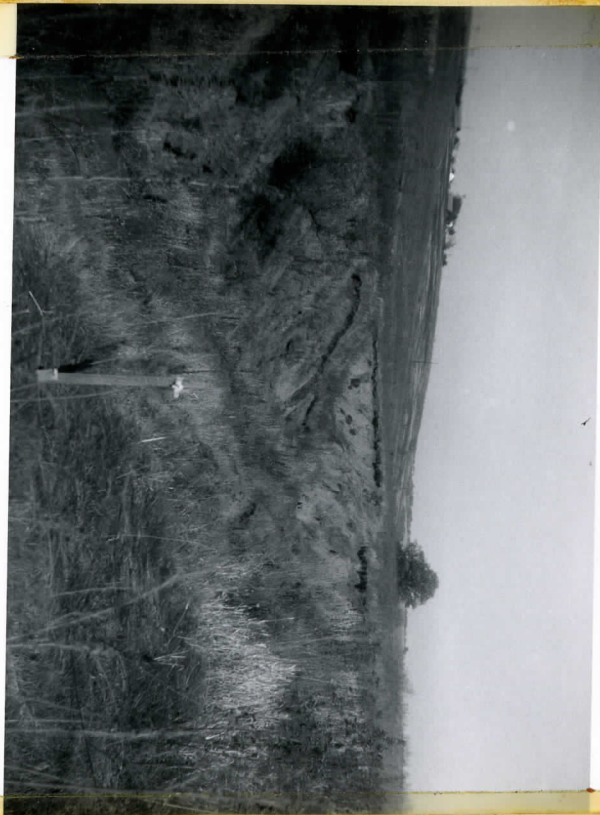
Views show centerline of pipe spillway before and during construction. About eight feet of excavation was necessary at the upper end by the riser.
